STS-107
Launch+4 Day
Consolidated Film/Video Report
KSC, JSC, MSFC and Program Integration
Film/Video Analysis Teams

22 January 2003

This report consolidates the multi-center post flight photo reviews into a single list of observations for engineering review. This integrates the photo review process into the IFA / PRACA process to ensure that the identified observations are assessed and dispositioned prior to the next flight per established problem reporting criteria.

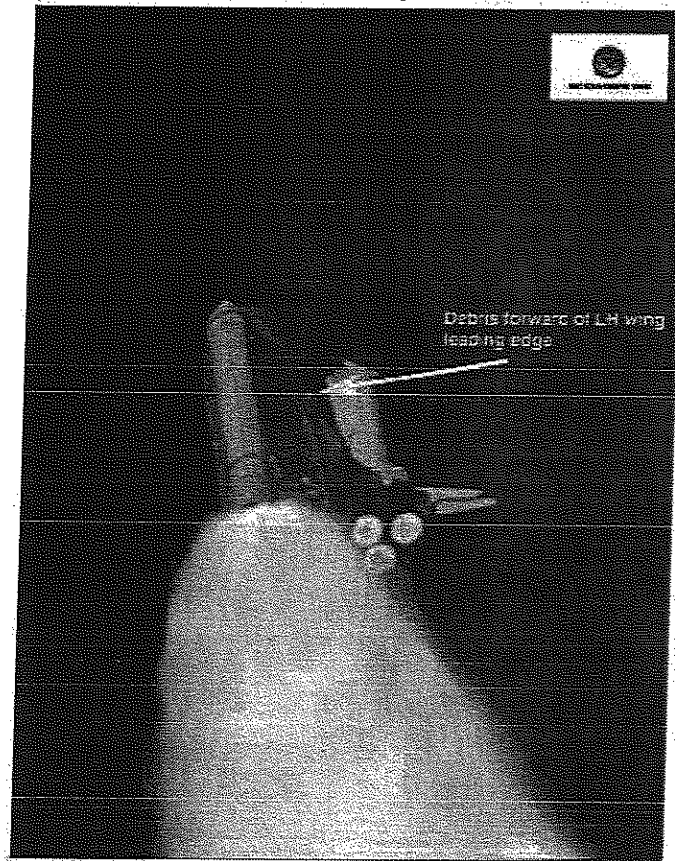
During ascent at approximately 81 seconds MET, debris was seen to originate from an area near the ET/Orbiter forward attach bipod. Due to lighting conditions in the area, it is not known whether the debris originated as a single item which broke up or if it originated as several separate items. Four objects are seen or surmised from the data.

Object #1, the largest of the items, was a light-colored piece of debris which appeared (016:15:40:21.699 UTC) to move outboard in a -Y direction, then fell aft along the left Orbiter fuselage and struck the underside (-Z) of the leading edge of the left wing (016:15:40:21.882 UTC). The strike appears to have occurred on or relatively close to the wing glove near the Orbiter fuselage. After striking the left wing, the debris broke into a spray of white-colored particles that fell aft along the underside (-Z side) of the Orbiter left wing. The spray of particles was last seen near the LSRB exhaust plume.

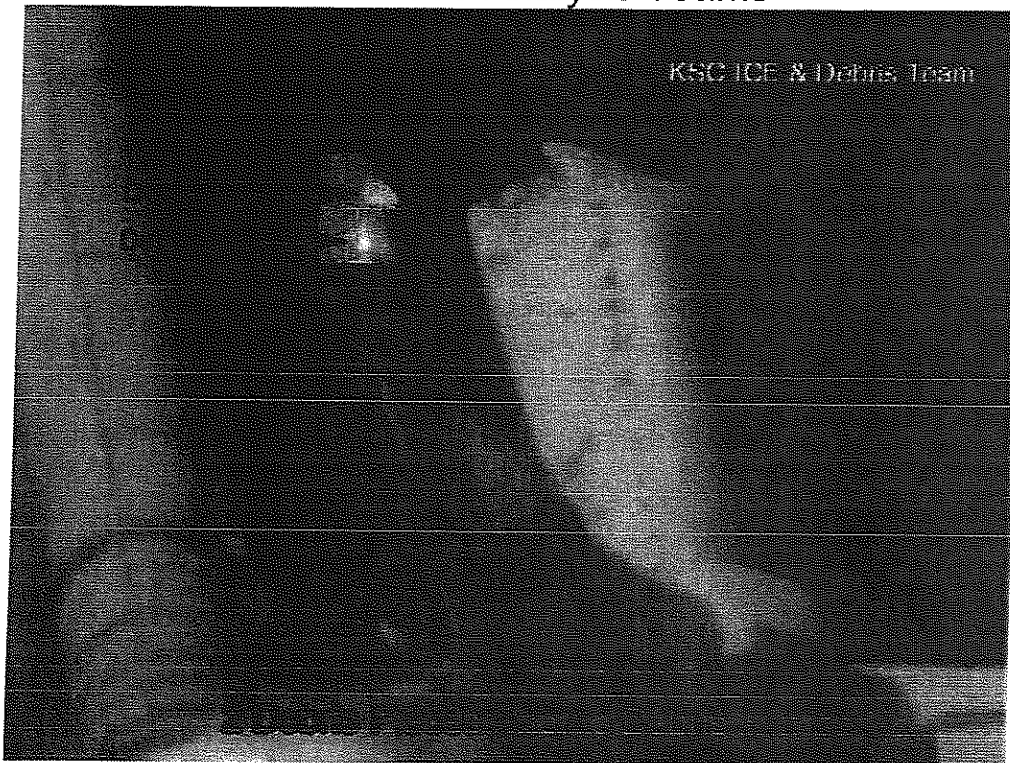
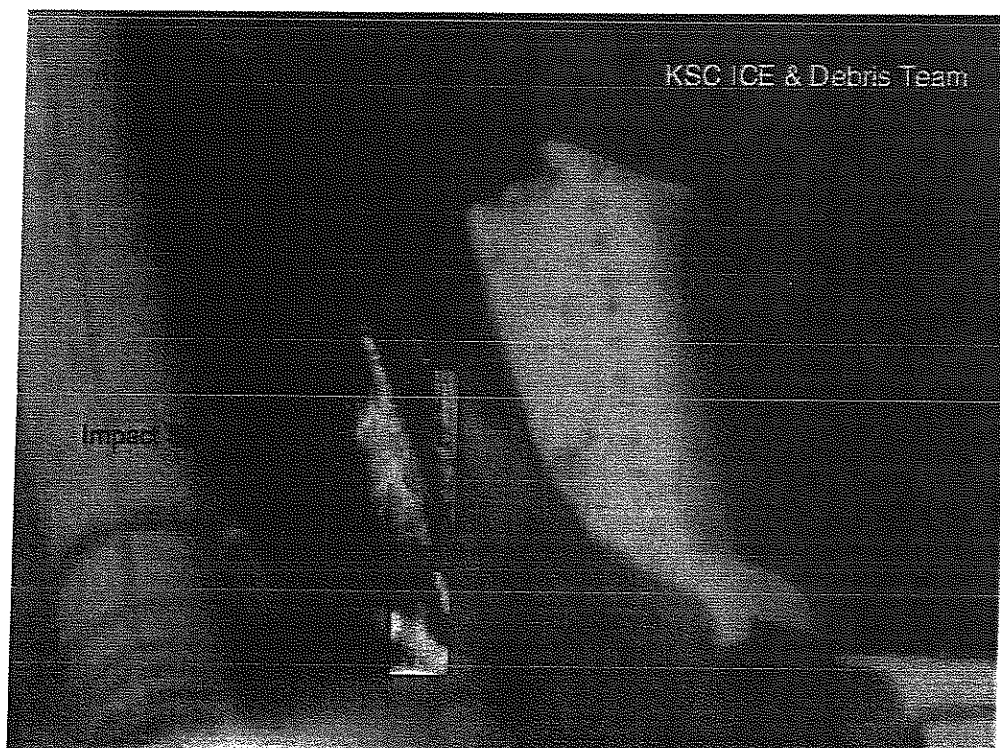
Comparison views of the strike area immediately before and after the event were examined for indications of damage to the wing. The resolution on the films and videos is insufficient to see individual tiles. Of the multiple views that should have been available to view this event, many were unuseable. Based on the resolution of the views available, no conclusions can be reached on the extent of any damage that may have occurred from this event.

Secondary effects from the spray of materials following the strikes was also considered. The MER was contacted to determine the Elevon positions at the time of the strike. Since the Left Inboard Elevon was slightly down, there is also the possibility of strikes there.

A preliminary assessment of debris impact conditions predicted an impact to the Orbiter lower surface at location Xo1049, Yo185 (results provided on January 17, 2003) Impact velocity was estimated to be approximately 750 ft/sec with an impact angle estimated to be less than 20 degrees.

Further analysis will be performed.

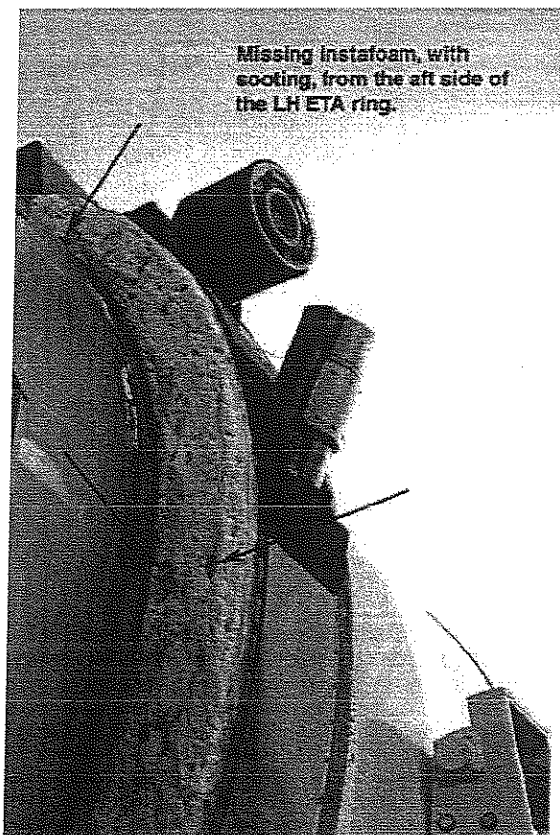
CFVR-107-02

Camera: E-220, E-222, E-223, E-224
Time: UTC 15:39:33.196

Approximately 33 seconds after T-0 (15:39:33.196 UTC) several particles are observed falling away from the -Z portion of the LH SRB ETA ring. Particles are probably pieces of the instafoam closeout on the ETA ring. (E-220, E-222, E-223, E-224)

The LH ETA ring instafoam closeout exhibited missing foam on the aft side. The areas of missing foam were sooted, indicating they came off in flight and not as the result of water impact. The largest area was approximately 3 inches in diameter by 2-1/2 inches deep. This appears to correlate with the debris seen coming from this area on the tracking films (E-220, E-222, E-223, E-224).

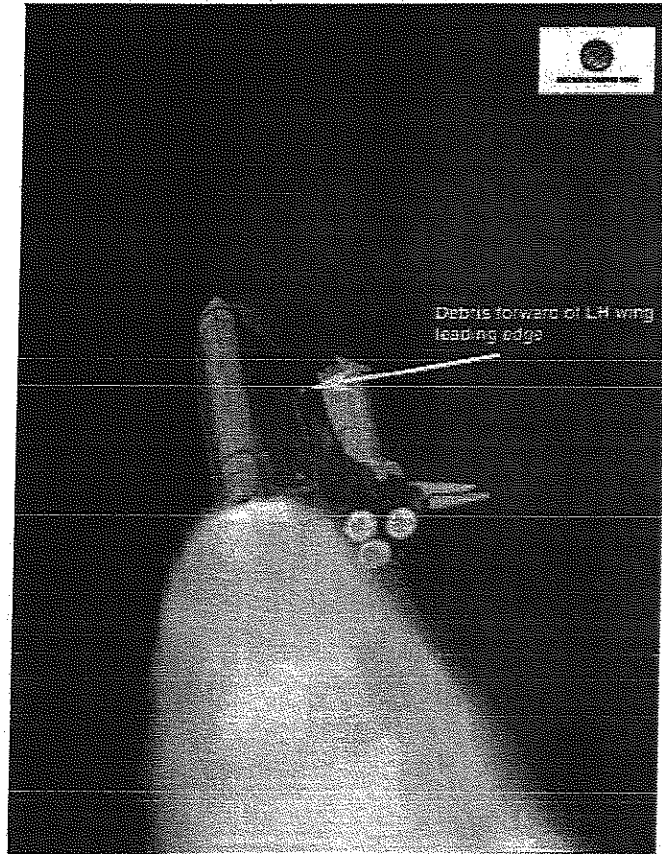
CFVR-107-01

Camera: E204, E208, E212
Time: UTC 016:15:40:21.699

Object #2, darker and smaller in appearance than the first, is visible in the frame immediately following the appearance of Object #1. Its travel path seems to be slightly more outboard and more in the -Z direction than the first. This object actually strikes the wing before Object #1. (A spray of particles is seen traversing aft prior to the strike from Object #1).

Object #3 is not seen directly in any views. However, evidence of its existence comes from a second spray of particles at the same time as and parallel to the spray from Object #2.

Object #4 does not appear to strike the Orbiter, but is seen as it crosses over the ET vertical strut. This object may be part of the debris cloud from Object #2/3.

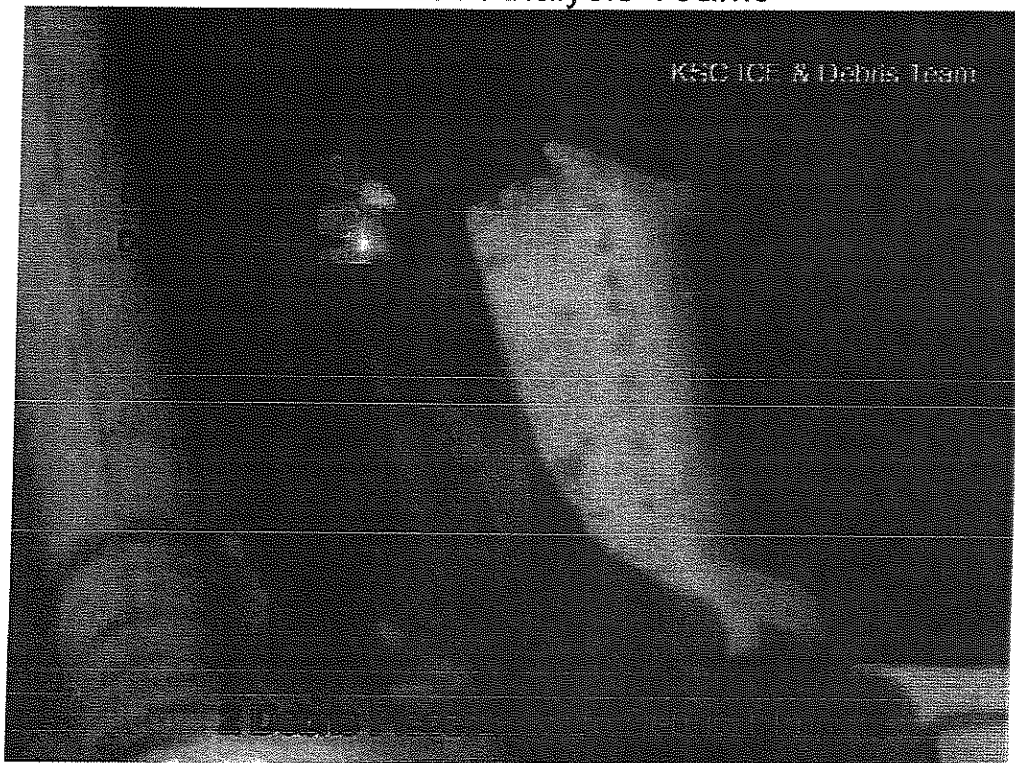
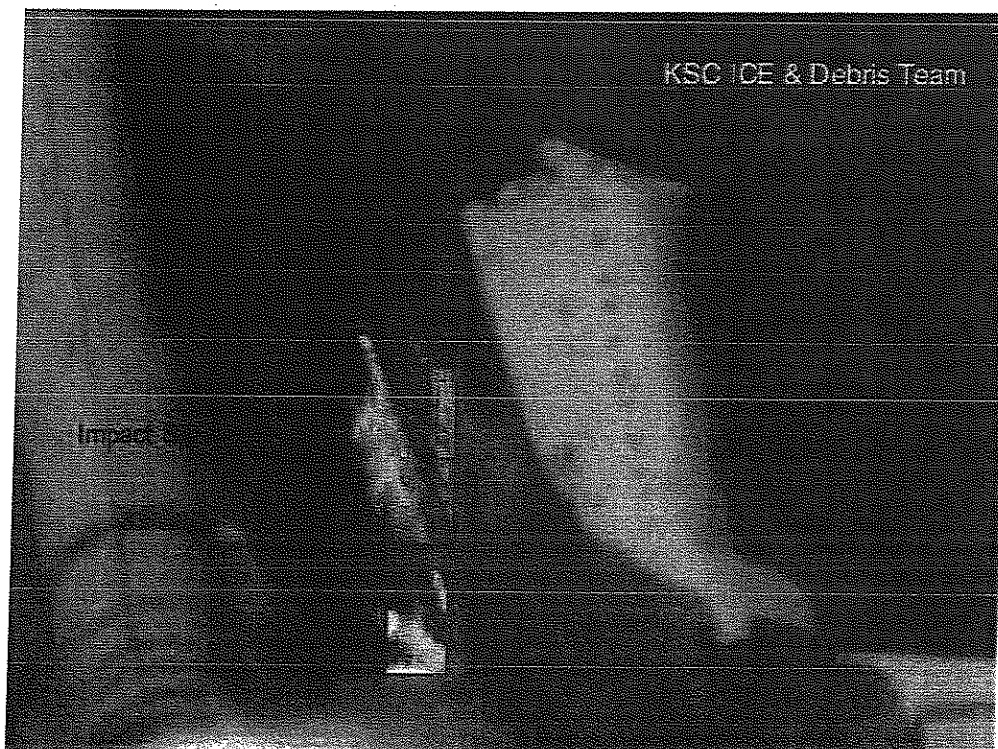
Comparison views of the strike area immediately before and after the event were examined for indications of damage to the wing. The resolution on the films and videos is insufficient to see individual tiles. Of the multiple views that should have been available to view this event, many were unuseable. Based on the resolution of the views available, no conclusions can be reached on the extent of any damage that may have occurred from this event.

Secondary effects from the spray of materials following the strikes was also considered. The MER was contacted to determine the Elevon positions at the time of the strike. Since the Left Inboard Elevon was slightly down, there is also the possibility of strikes there.

A preliminary assessment of debris impact conditions predicted an impact to the Orbiter lower surface at location Xo1049, Yo185 (results provided on January 17, 2003) Impact velocity was estimated to be approximately 750 ft/sec with an impact angle estimated to be less than 20 degrees.

Further analysis will be performed.

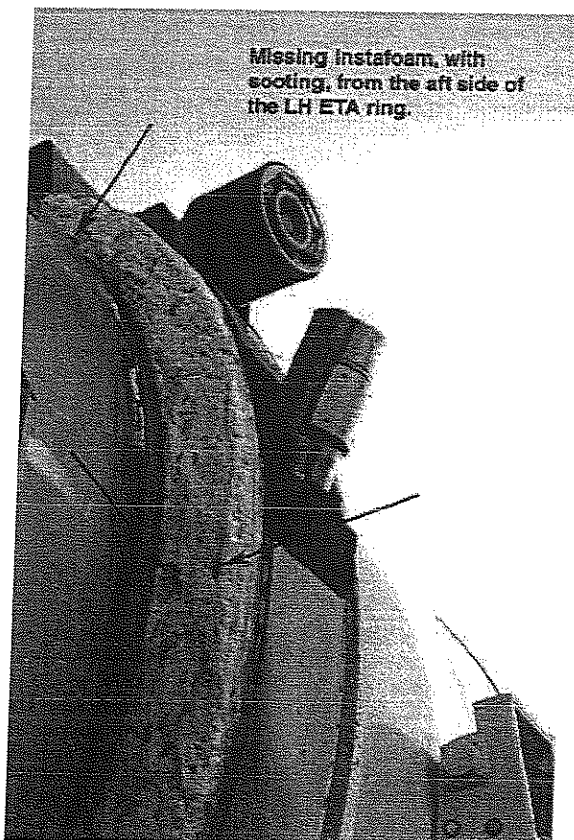
CFVR-107-02

Camera: E-220, E-222, E-223, E-224
Time: UTC 15:39:33.196

Approximately 33 seconds after T-0 (15:39:33.196 UTC) several particles are observed falling away from the -Z portion of the LH SRB ETA ring. Particles are probably pieces of the instafoam closeout on the ETA ring. (E-220, E-222, E-223, E-224)

The LH ETA ring instafoam closeout exhibited missing foam on the aft side. The areas of missing foam were sooted, indicating they came off in flight and not as the result of water impact. The largest area was approximately 3 inches in diameter by 2-1/2 inches deep. This appears to correlate with the debris seen coming from this area on the tracking films (E-220, E-222, E-223, E-224).
